## **Solubility of limestone and seepage problems in the left abutment of the Marun dam, southwest of Iran**

### **Abstract**

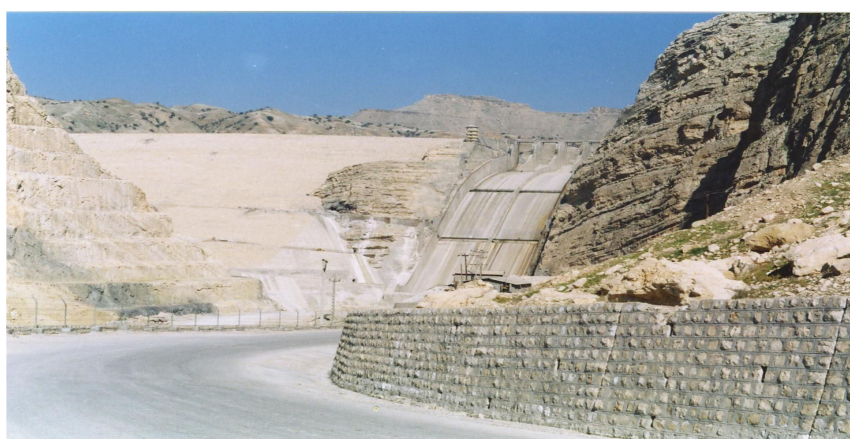
The 170m high rock fill dam regulates the waters of the Marun River. Also, it serves power generation, flood control and irrigation needs (Fig.2).

**Fig.2. A photo of Marum dam (downstream).**

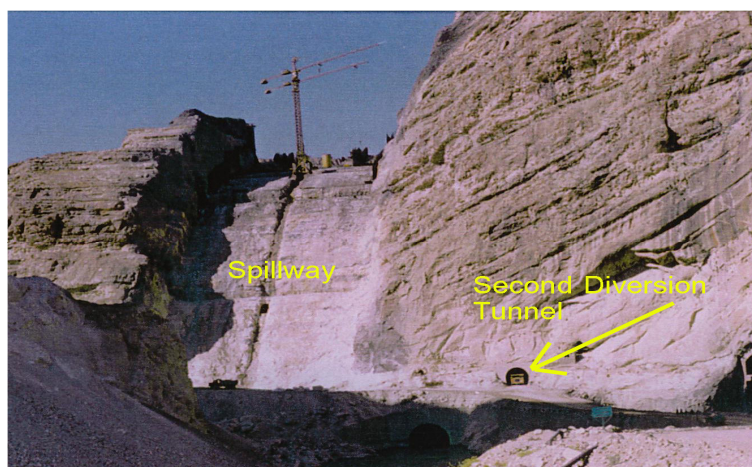
tunnels in the left abutment. The largest discharge occurred in the second diversion tunnel (Fig. 5).

**Fig.5. A photo of the second diversion tunnel in the left abutment.**

The total amount of water leakage through the left bank of Marun dam was about  $10m^3 / s$ . All appeared from tunnels and galleries only. No spring was observed along the left bank of the river in the downstream of the dam site.

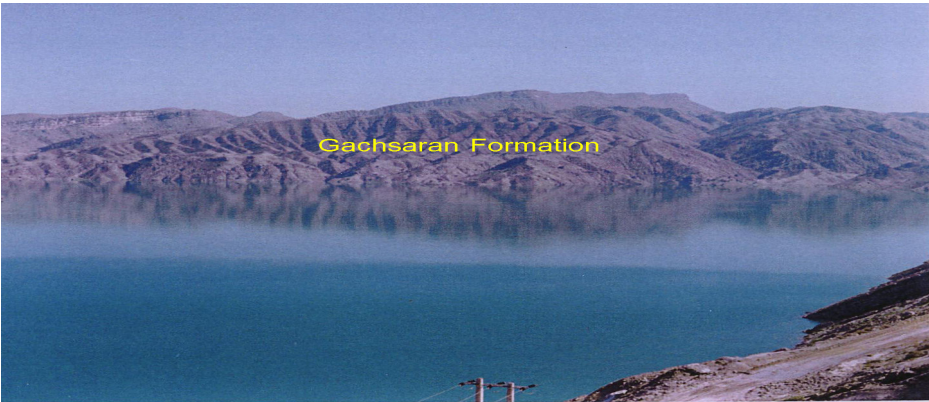
“Principal Vuggy Zone” (PVZ), which is overlain by impervious shale. The upper Asmari limestone (As-3), just downstream of the dam is very karstified. It consists of well developed voids which locally occur with traces of dissolution phenomenon continuity. These dissolutions are more evident along fissuring or stratification planes in cores or outcropping surfaces. The Asmari limestone is covered by the much karstified overlying Gachsaran Formation, with a number of sinkholes, caves and fissures (Fig.7).

Fig. 7. The dam reservoir is covered by the very karstified Gachsaran Formation, with a number of sinkholes, caves and fissures.
