Solubility of limestone and seepage problems in the left abutment of the Marun dam, southwest of Iran

M.H.Ghobadi: Bu-Ali Sina University,
Geology Department,

R. Karami: Shahid Chamran University,
Geology Department, Ahvaz

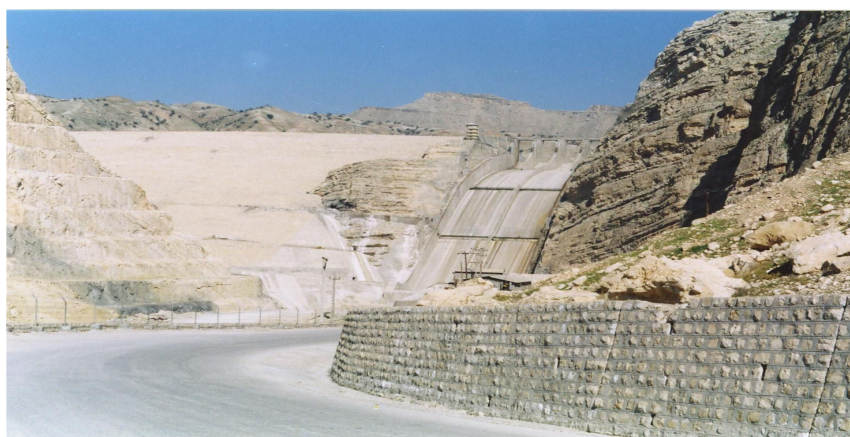
The 170m high rock fill dam regulates the waters of the Marun River. Also, it serves power generation, flood control and irrigation needs (Fig.2).

**Fig.2. A photo of Marum dam (downstream).**
