## **Solubility of limestone and seepage problems in the left abutment of the Marun dam, southwest of Iran**

M.H.Ghobadi: Bu-Ali Sina University,  
Geology Department,

R. Karami: Shahid Chamran University,  
Geology Department, Ahvaz

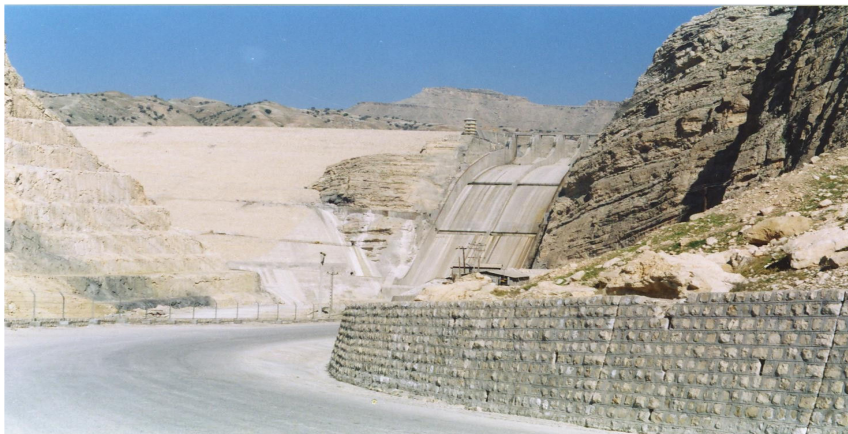
The 170m high rock fill dam regulates the waters of the Marun River. Also, it serves power generation, flood control and irrigation needs (Fig.2).

**Fig.2. A photo of Marum dam (downstream).**

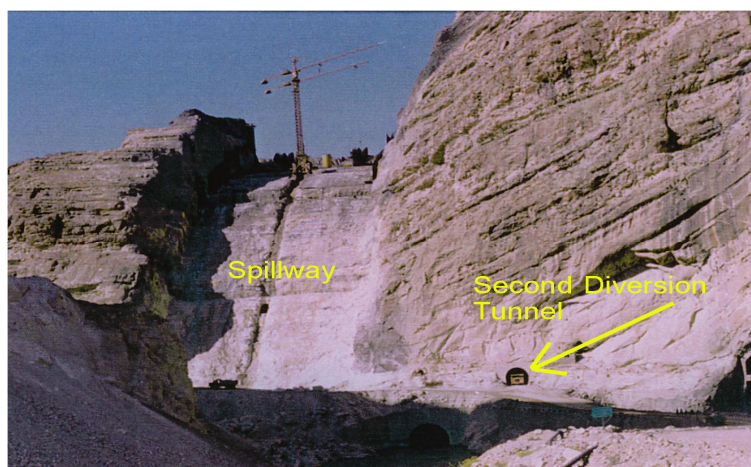
The reservoir level was 40m only. As a consequence of washing process discharge from LA-3 in few days increased to  $1.5 \text{ m}^3 / \text{s}$ . Simultaneously, much larger leakage appeared at several places in the second diversion tunnel, and at a few more points in galleries and

tunnels in the left abutment. The largest discharge occurred in the second diversion tunnel (Fig. 5).

**Fig.5. A photo of the second diversion tunnel in the left abutment.**

The total amount of water leakage through the left bank of Marun dam was about  $10m^3 / s$ . All appeared from tunnels and galleries only. No spring was observed along the left bank of the river in the downstream of the dam site.

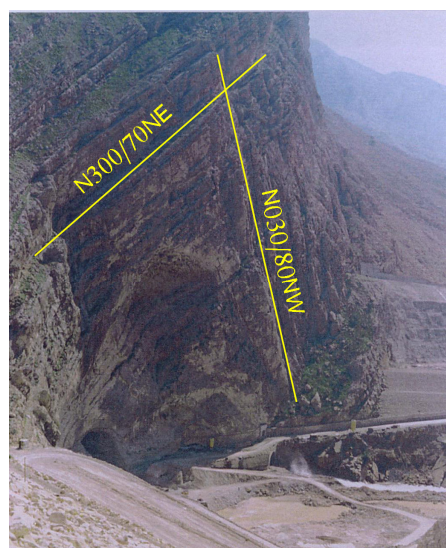
**Fig.8. Several joint sets cut the Asmari limestone at the site. The rock mass is cut by two major sets of joints. One major joint set strikes 030 and dips 80 degree NW. The other major joints set strike 300 degree and dips 70 degree NE.**

A few minor faults traverse the dam site. These faults are the result of shearing stresses developed in the bedding. Most of these faults are roughly parallel to the strike of major joint sets and they dip steeply. Vertical displacements along the faults are small, ranging from a few centimeters to about 2 m. Fault surfaces, explored by adits, were found to be slightly open at the surface but closed in many cases at depth. Several joint sets cut the Asmari limestone at the site. The rock mass is cut by two major sets of joints. One major joint set strikes 030 degree and dips 80 degree NW and the other major joints set strike 300 degree and dips 70 degree NE (Fig.8). Most of the joints exhibit some calcite filling, clay staining and weathering. Joint spacing ranges from 10 to 80 cm. Bedding planes, in conjunction with these joints, control the solubility in the Asmari limestone. Shearing along bedding planes was evident from place to place in adits by clay gouge between separated bedding surfaces. Fissures and cavities are often filled with erodible materials such as fine-grained silt or clayey silt.
